# UNDERWATER BRIDGE INSPECTION REPORT

STRUCTURE NO. 02545

CR NO. 116

RUM RIVER

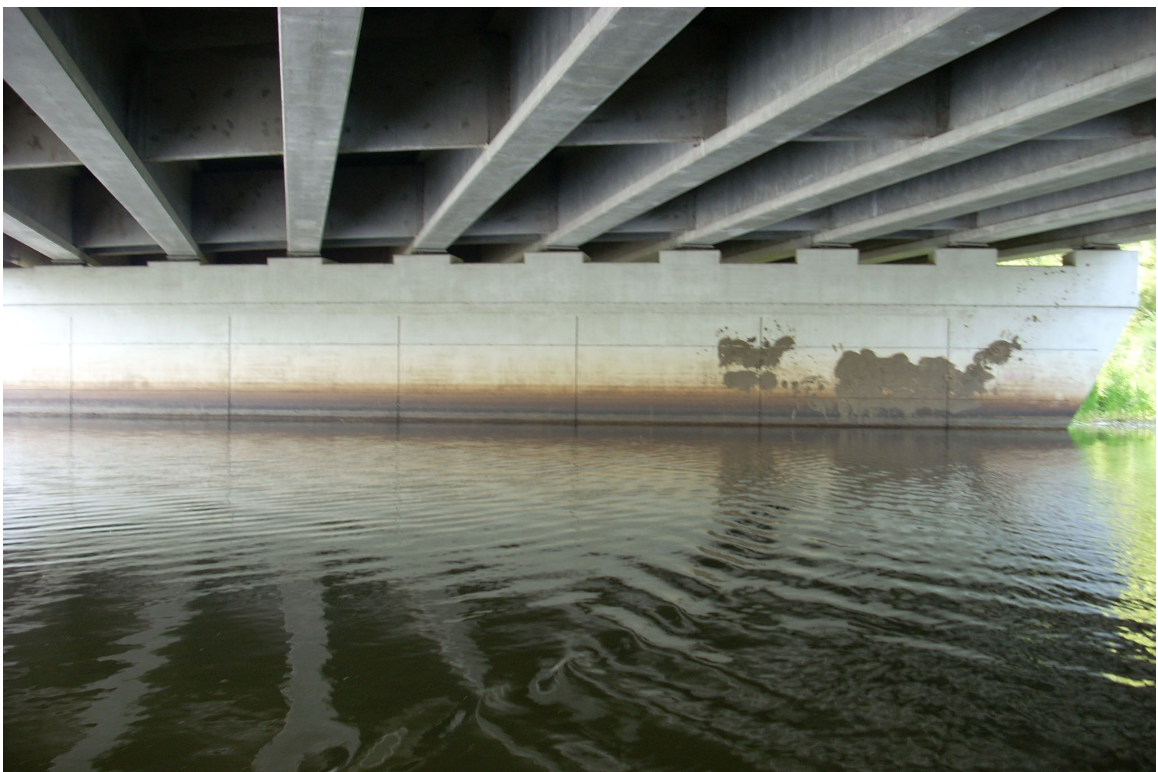
Photograph 2. View of Pier 1, Looking West.

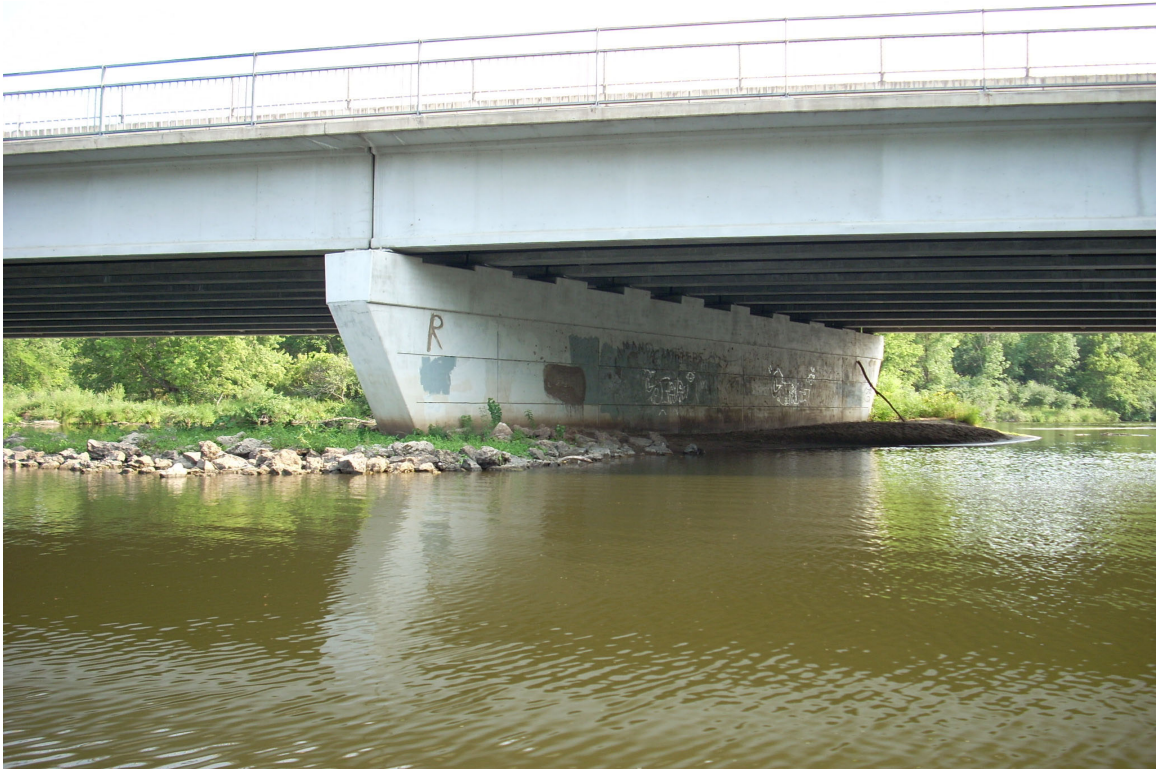
Photograph 3. View of Pier 2, Looking Southeast.

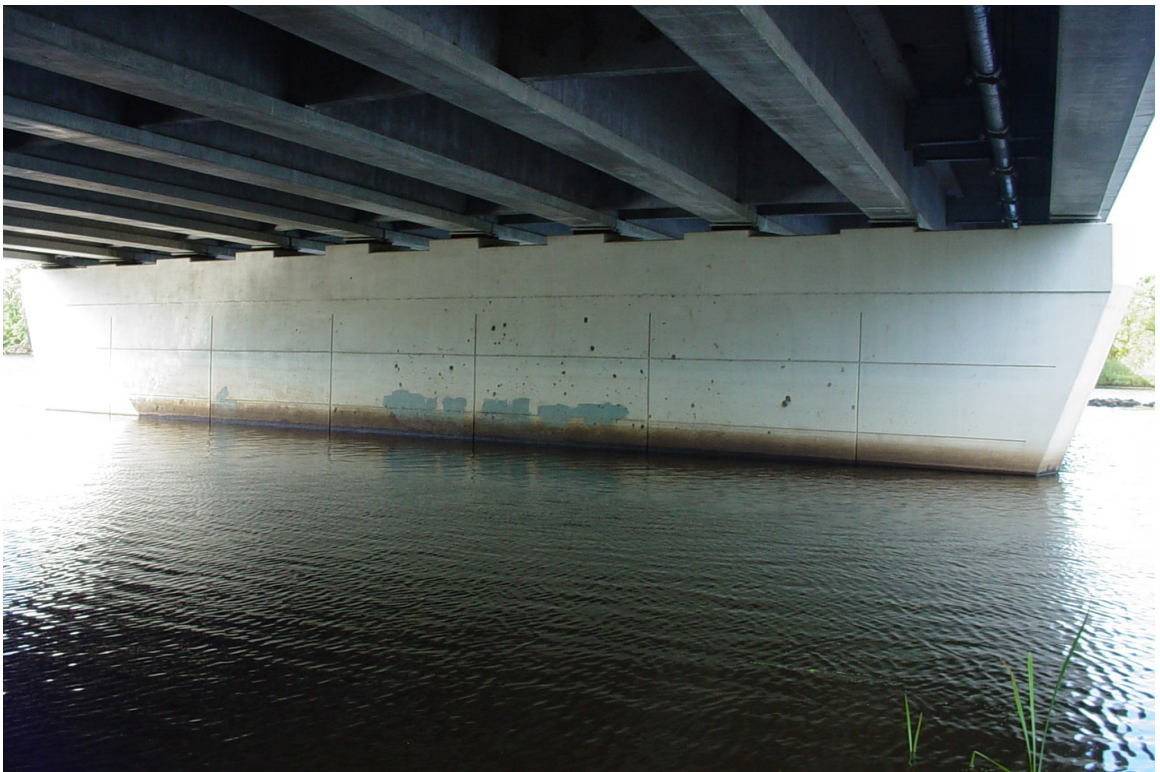
Photograph 4. View of Pier 3, Looking West.

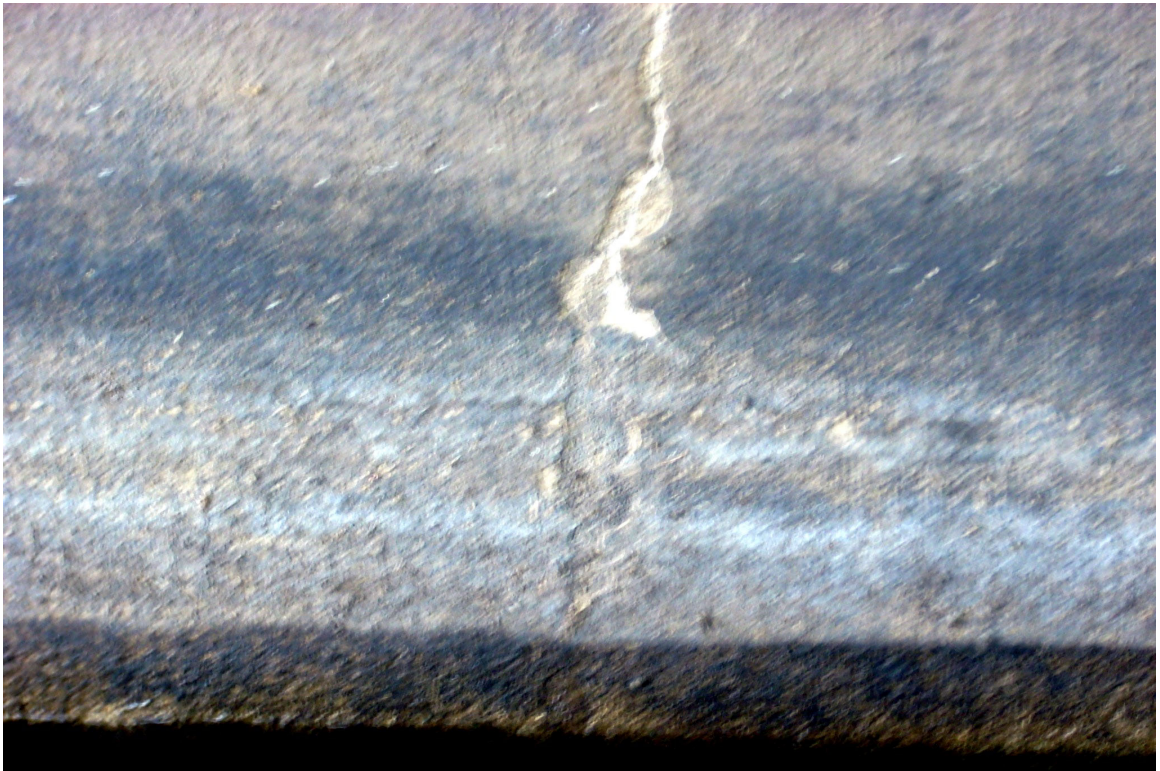
Photograph 7. View of a Typical Crack found on East face of Pier 3. Looking West

- The concrete was smooth and sound.
- The embankments consisted of grouted riprap.
- 7 hairline vertical cracks were observed on both faces of Piers 2 & 3 extending from the top of the pier cap to the channel bottom.

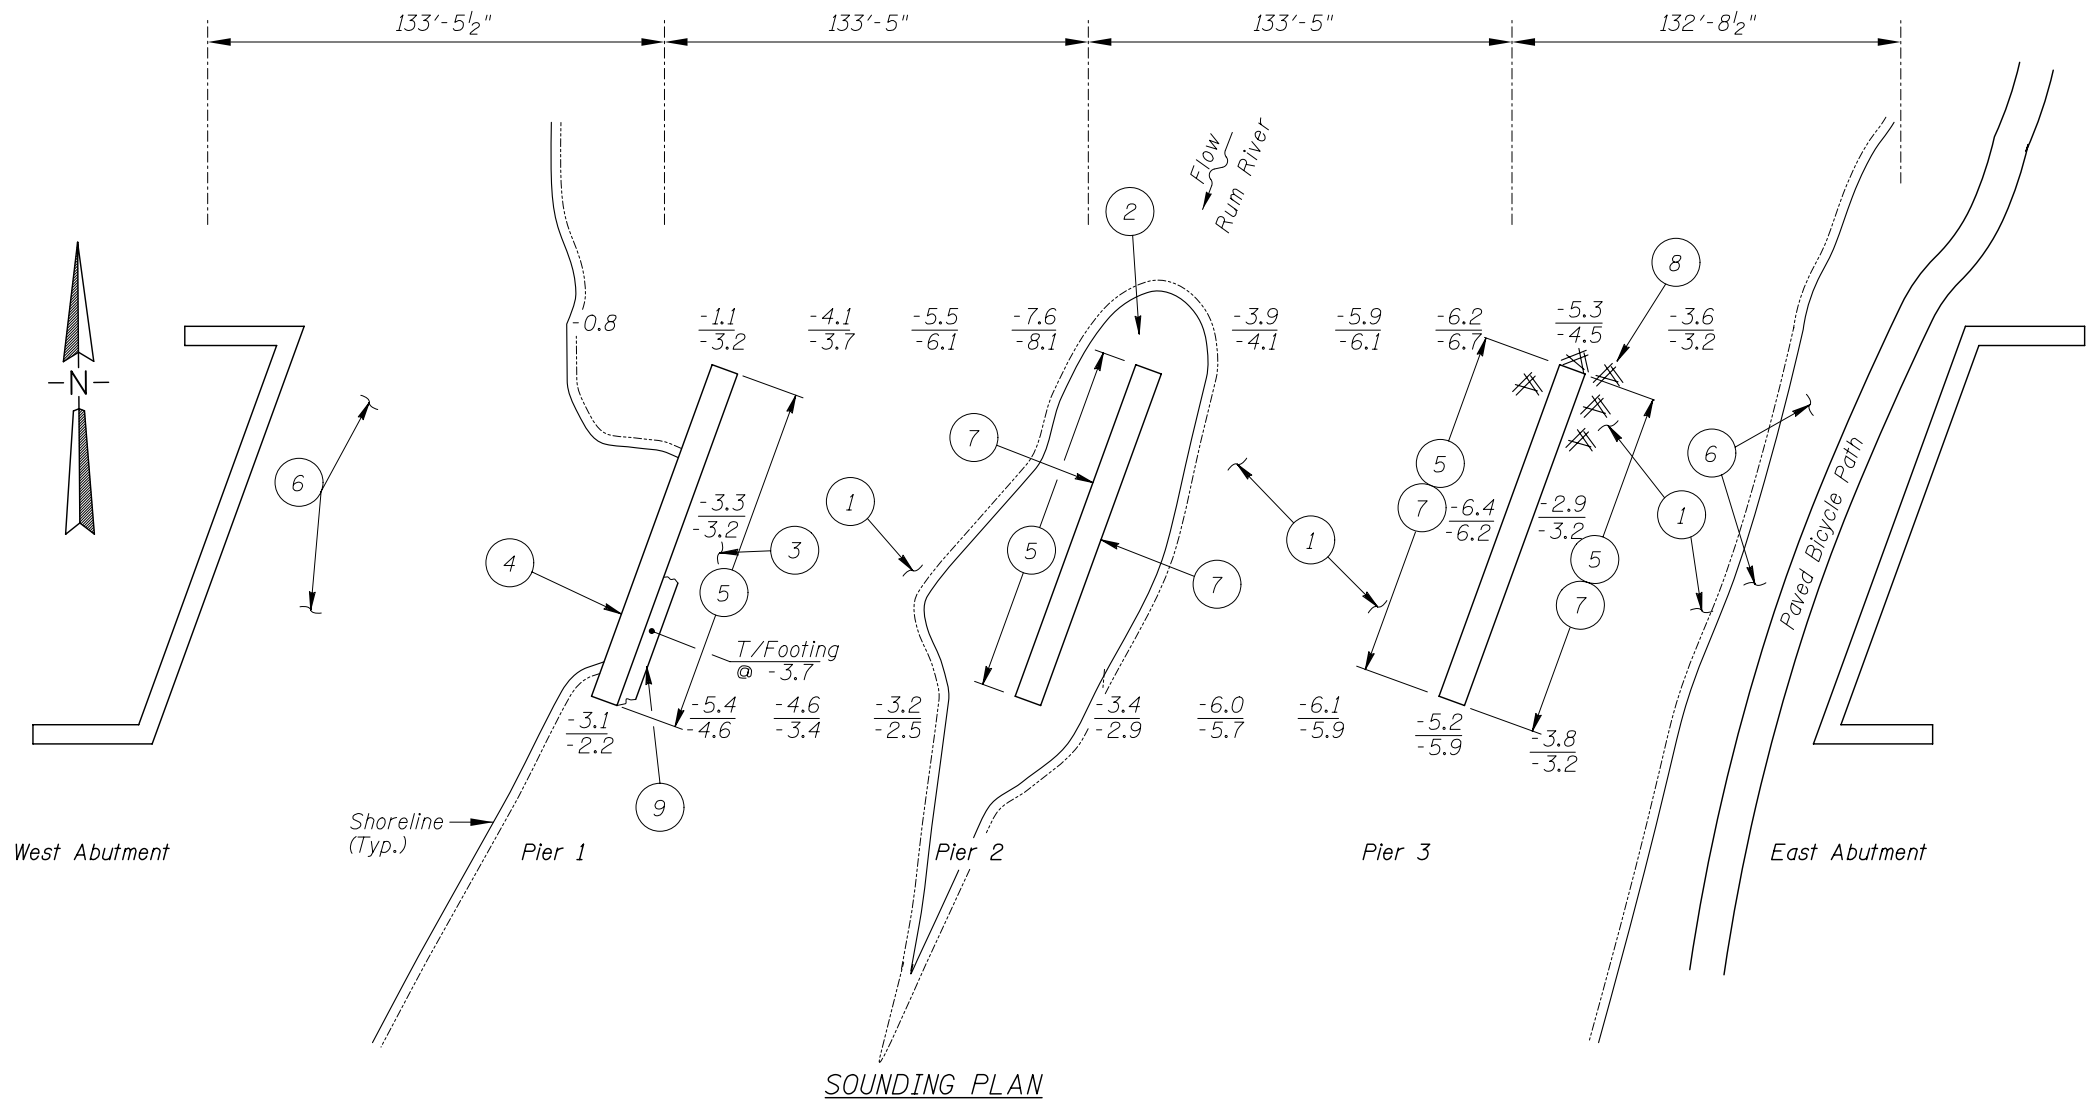
MINNESOTA DEPARTMENT OF TRANSPORTATION UNDERWATER BRIDGE INSPECTION		
STRUCTURE NO. 02545 OVER THE RUM RIVER DISTRICT 5, ANOKA COUNTY		
INSPECTION AND SOUNDING PLAN		
Drawn By: PRH	COLLINS ENGINEERS	Date: AUGUST, 2007
Checked By: MDK		Scale: NTS
Code: 52210106		Figure No.: 1

- The channel bottom consisted of sandy gravel with up to 1 foot of probe rod penetration.
- 1 to 2 foot diameter riprap was observed at the upstream end of Pier 2.

- The channel bottom around Pier 1 consisted of silty sand with up to 2 feet of probe rod penetration.
- 5 hairline vertical cracks were observed on both faces of Pier 1 extending from the top of pier to the channel bottom.

- A light accumulation of 8-inch-diameter and smaller timber debris was observed from 5 feet downstream of the upstream nose on the east face, around the upstream nose, to 20 feet downstream of the upstream nose along the west face. The debris extending from the channel bottom up 2 feet and up to 4 feet off the faces and nose.

- The top of footing was exposed at 3.7 feet below the waterline from the downstream nose to 15 feet upstream of the downstream nose along the east face of the pier with up to 3 inches of vertical exposure.

\* Monitor any footing exposure and give consideration to the removal of drift accumulations if found to be increasing during future underwater inspections.
